Reeve Memorial Union

Facility Assessment
DSF No. 08127Z.08

November 2011
Revised January 2012

Reeve Memorial Union - Facility Assessment
University of Wisconsin-Oshkosh | Oshkosh, WI
Comm. No. 5325

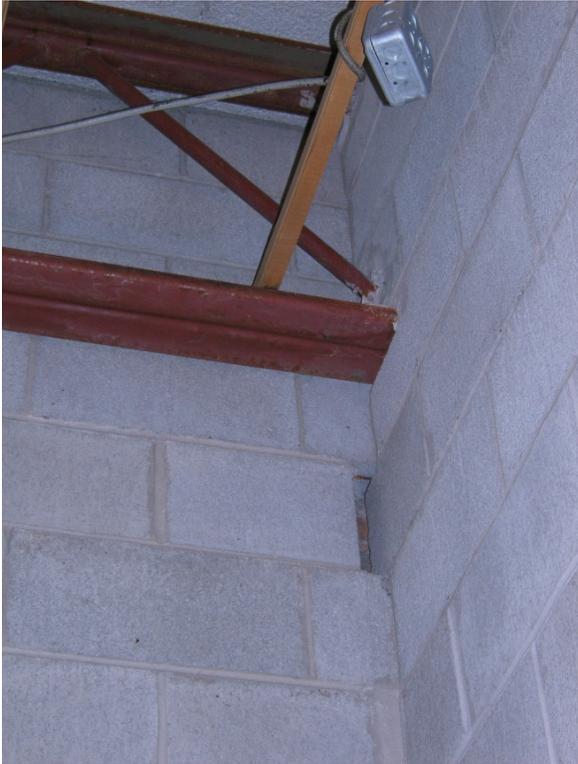
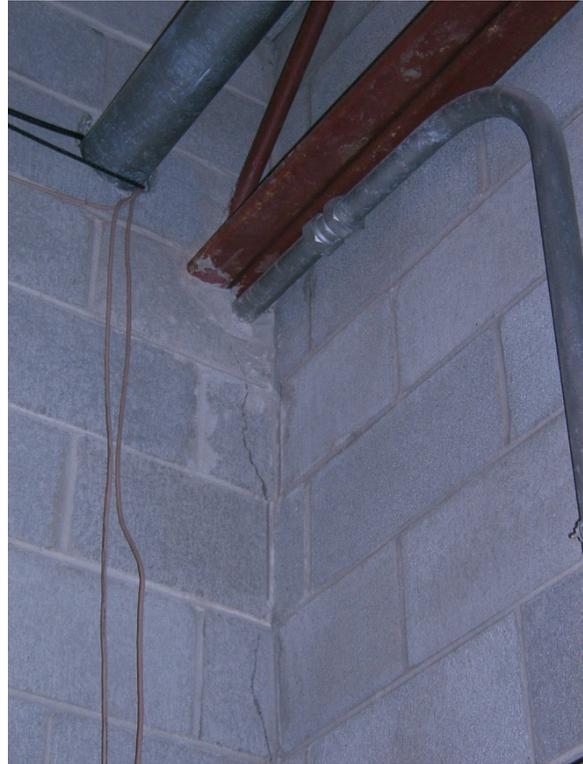
Mech. Equip. 204 - Joist bridging observed to be adequately in place per original drawings (left photo). Cracks in concrete block wall, at north corner, below joist bearing (right photo).

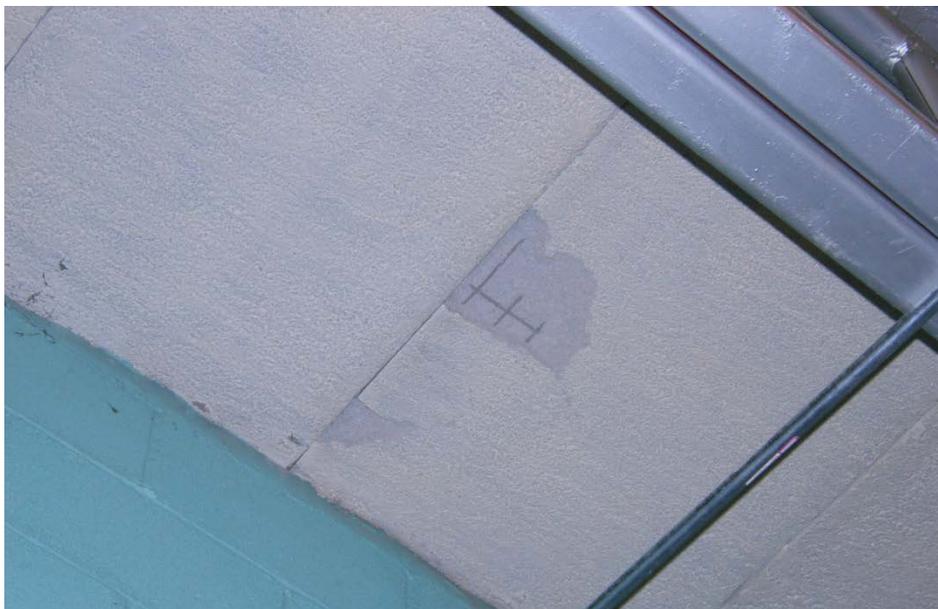
Storage 205 – Spalled concrete on underside of precast concrete roof deck. Reinforcing is left exposed and could lead to corrosion.

- Repair spalled concrete from underside of precast roof deck. Apply epoxy coating to all exposed reinforcing prior to making the repair.
- Repair cracks at interior concrete block and structural glazed tile walls. Windows at Stair 292 should be replaced prior to repairing cracks in structural glazed tile walls at each lower corner of window frames.

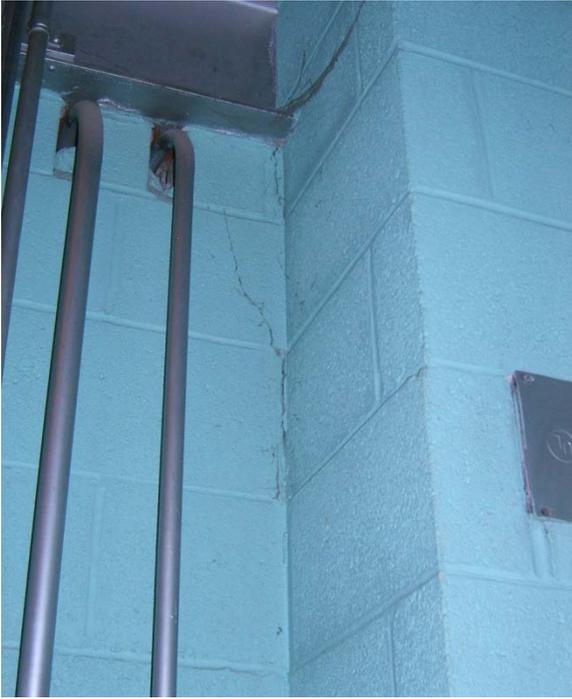
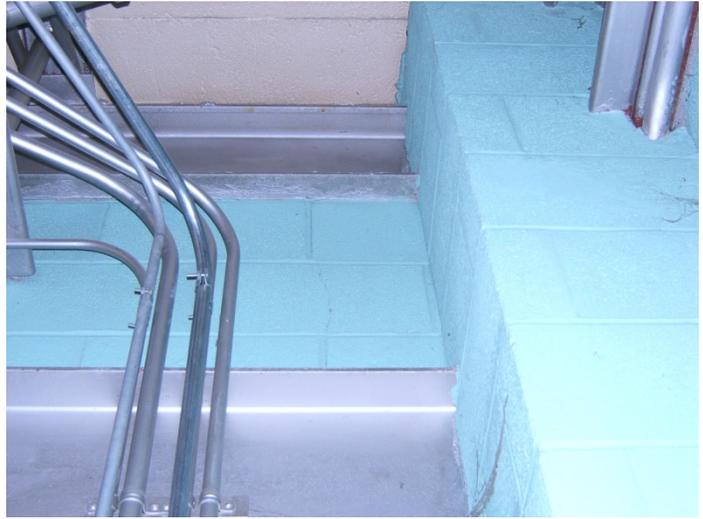
Storage 205 - Cracks in concrete block wall (high) at north corner of room.

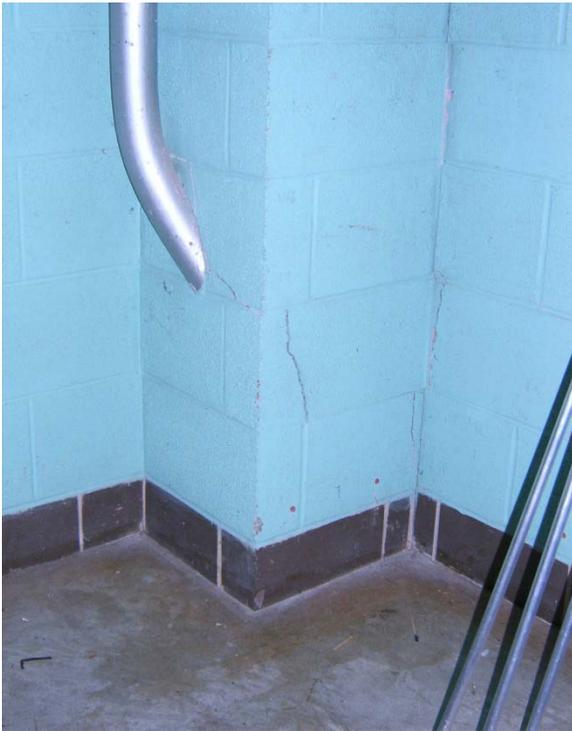
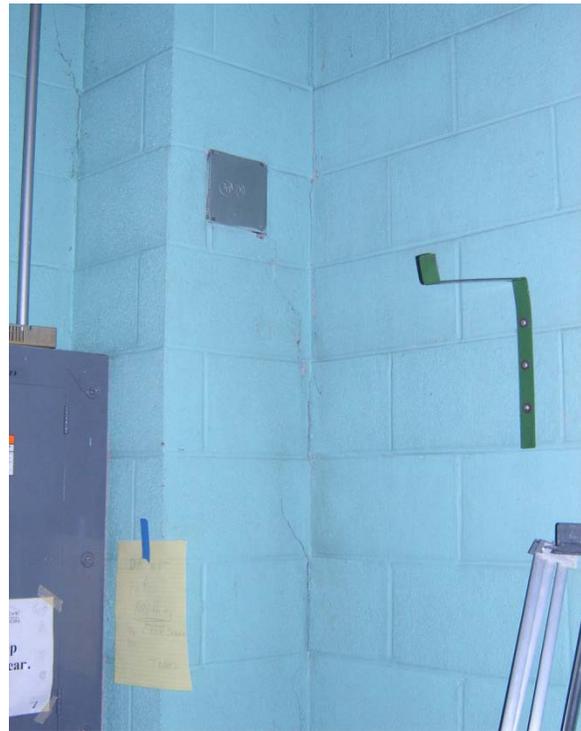
Storage 205 - Cracks in concrete block wall (low) at north corner of room.

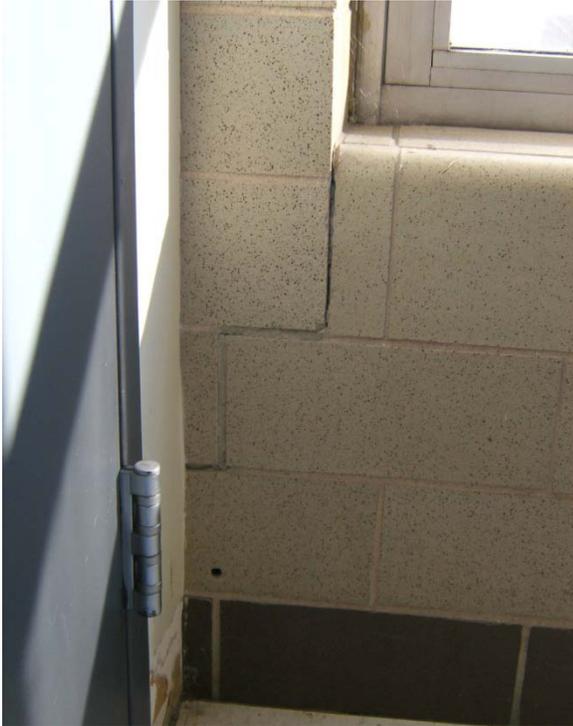
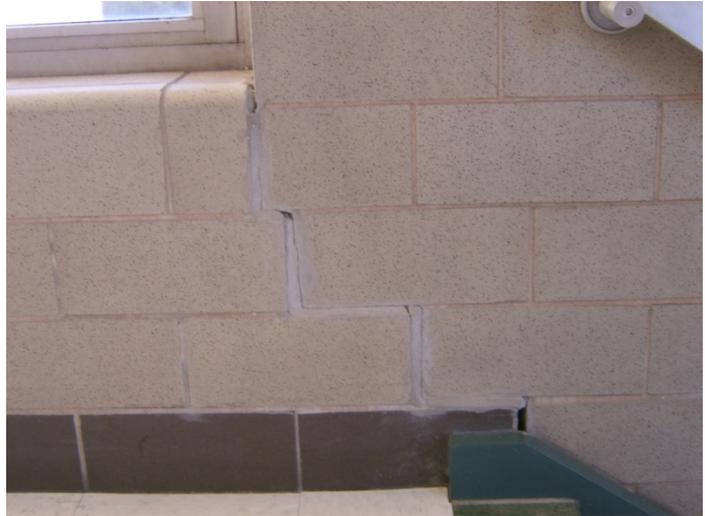
Stair 292 - Cracks in structural glazed tile at each lower corner of window frame.

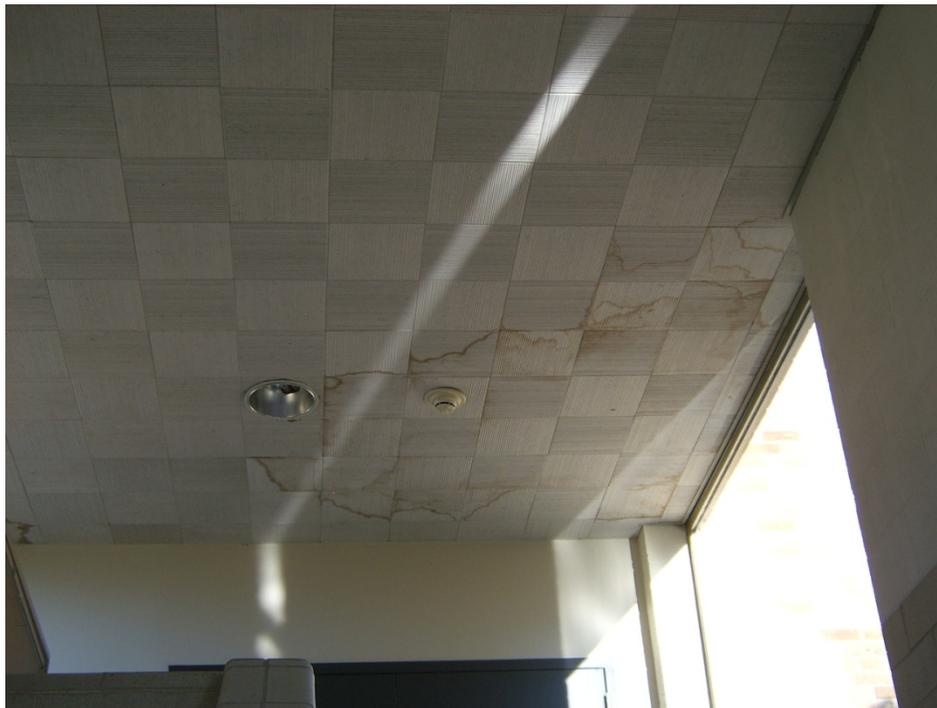
Stair 292 - Water stains at ceiling tiles indicate some sort of leak that has taken place.

- Investigate water stains at ceiling tiles to determine the underlining issue first and then take further corrective action as deemed necessary.
- Investigate handrail brackets for improper attachment. Adequately secure them to mounting surface.

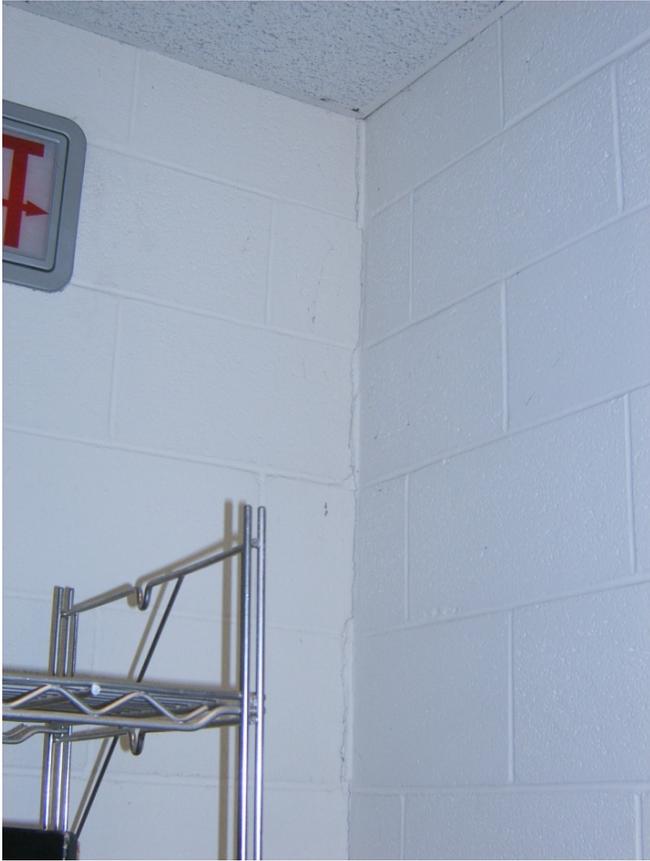
Corridor 280 - Cracks in concrete block walls at north and east corners of corridor adjacent to Stair 292.

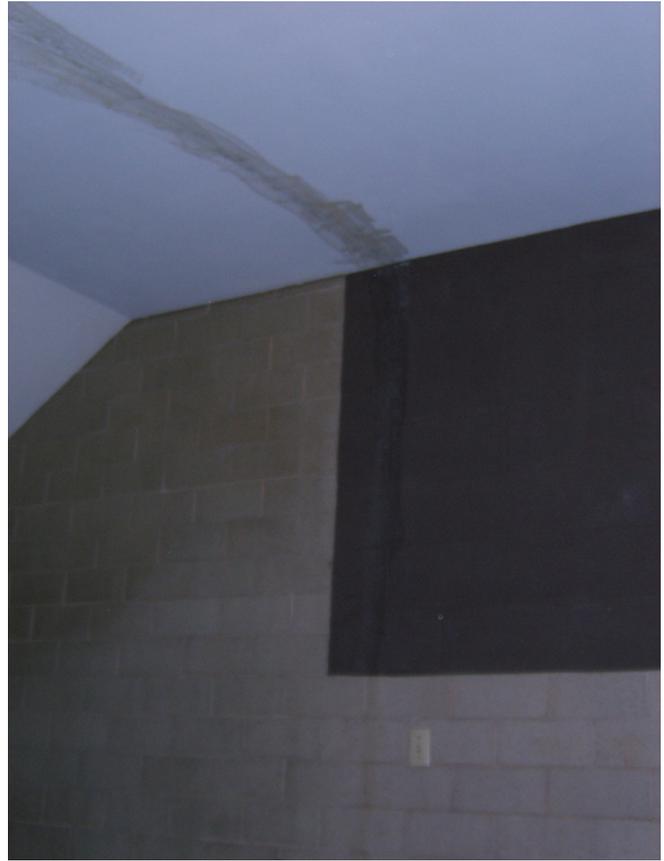
Stair 194 - Water stain at ceiling and northwest wall.

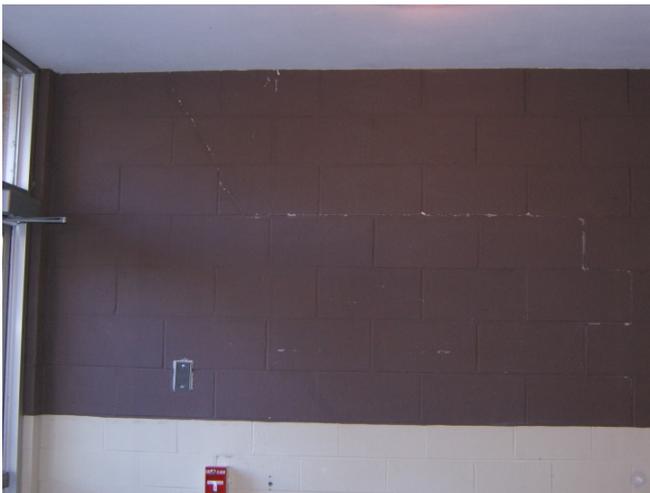
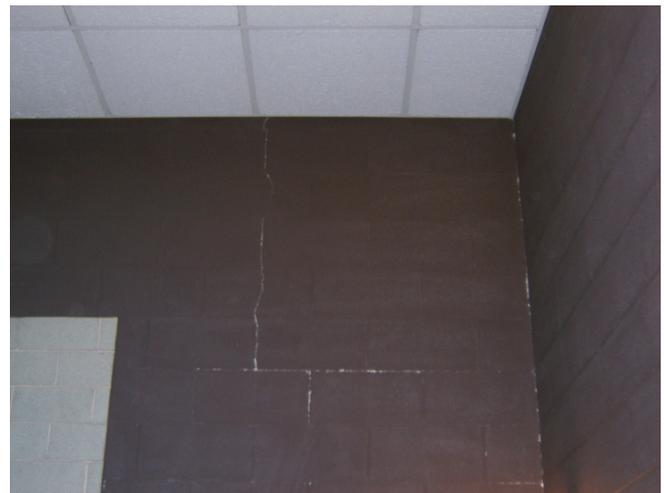
Stair 194 - Cracks in concrete block wall northeast of entrance doors.

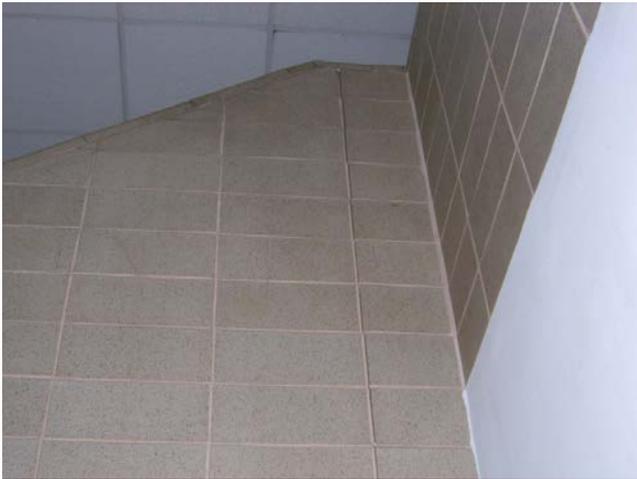
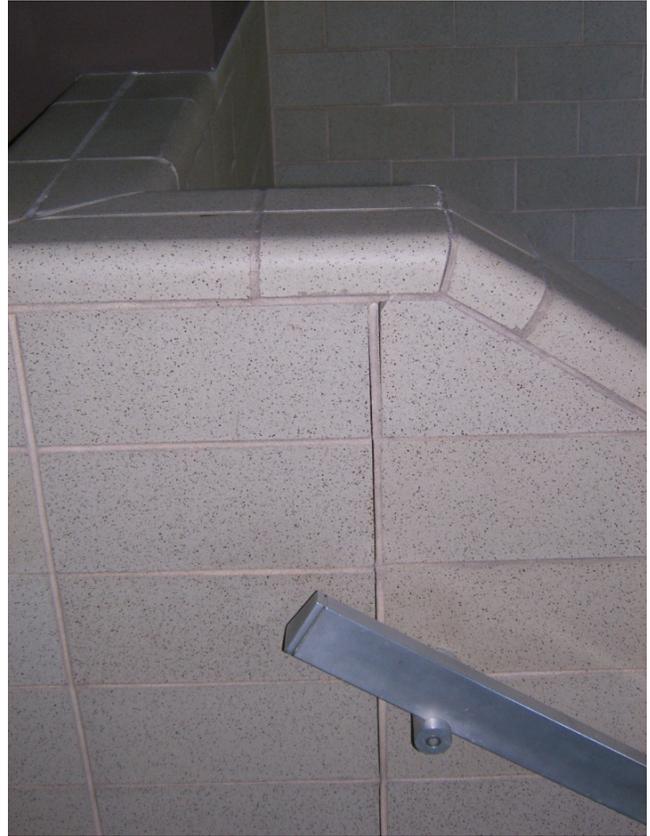
Stair 294 - Cracks in structural glazed tile "center" wall.

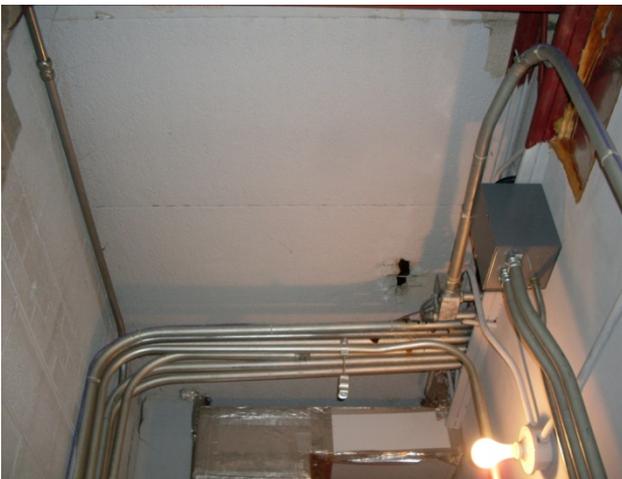
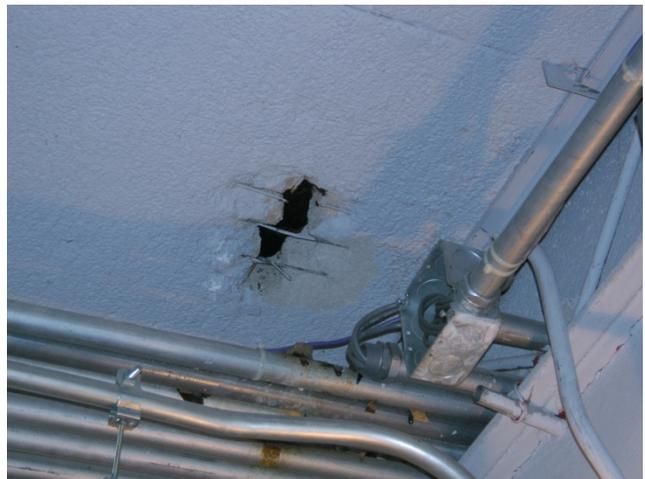
Storage 217A - Hole in precast roof slab. Reinforcing is left exposed and could lead to corrosion.

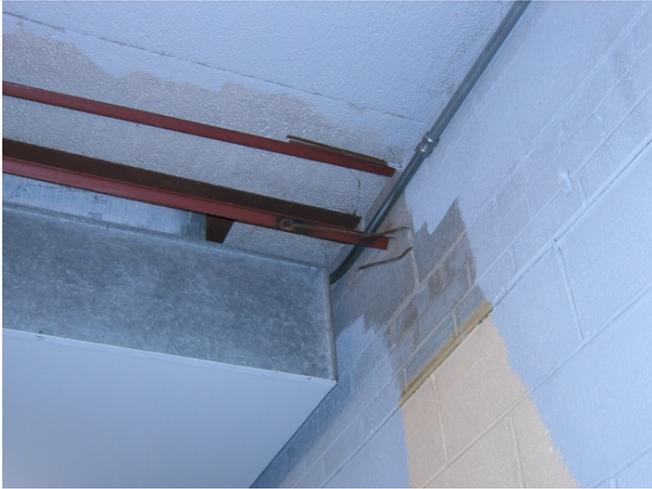
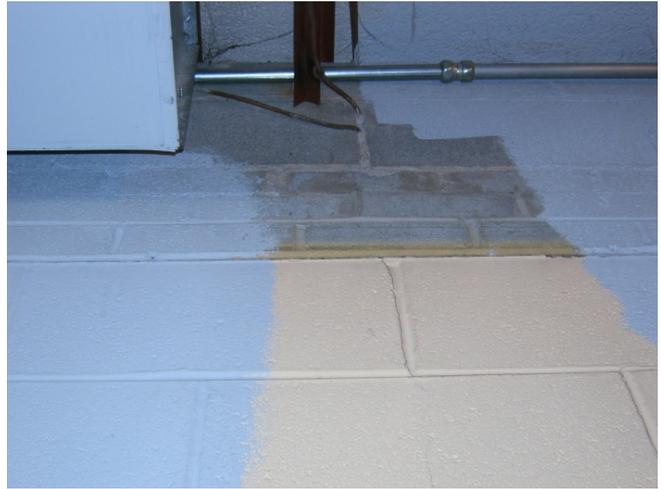
Storage 217A - Cracks in concrete block at northeast wall.

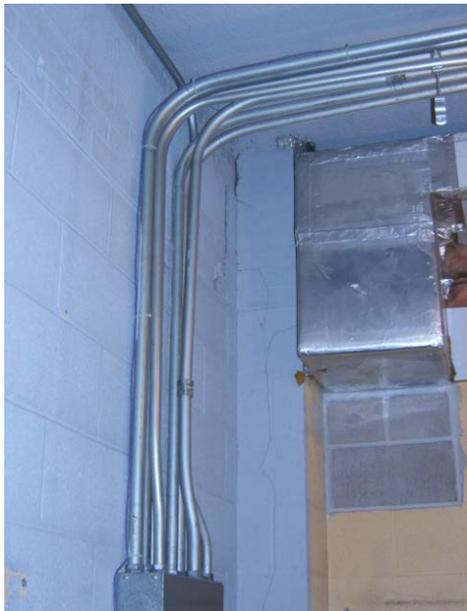
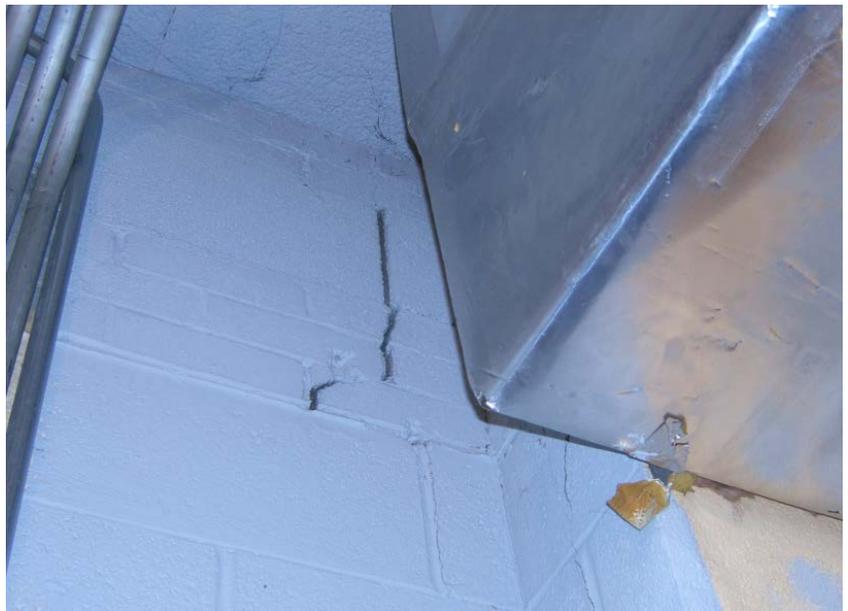
Storage 217A - Cracks in concrete block wall at east corner of room.

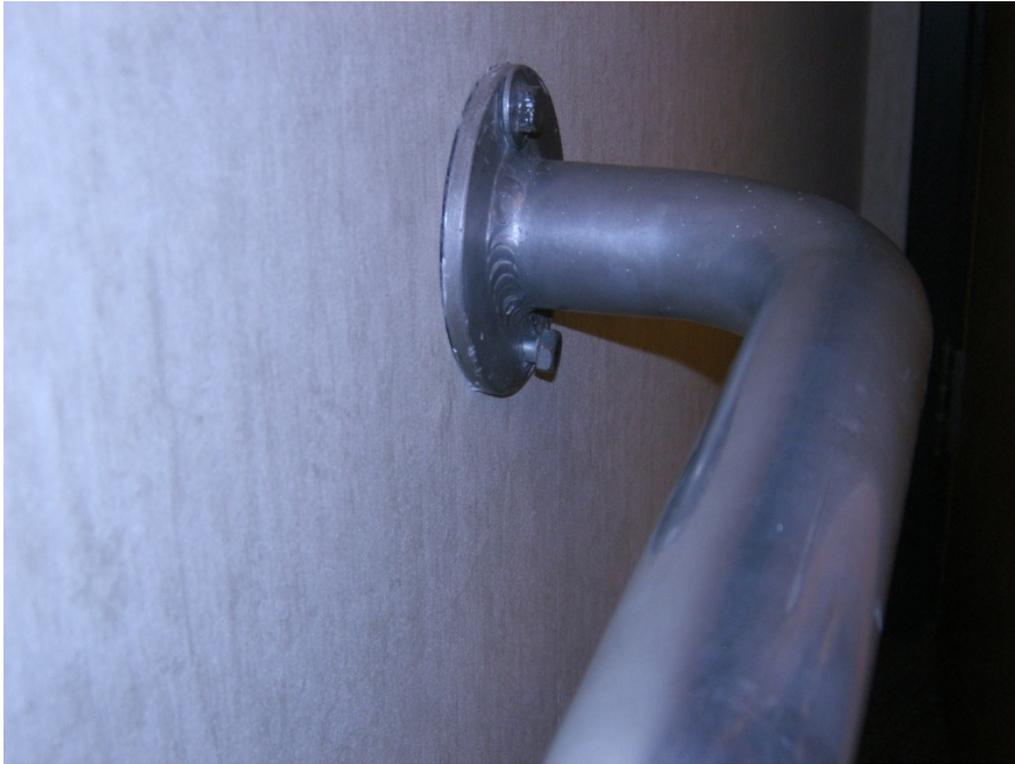
Stair 291 - Top mounting bracket of north handrail is completely loose. This must be capable of supporting a handrail load per State code.

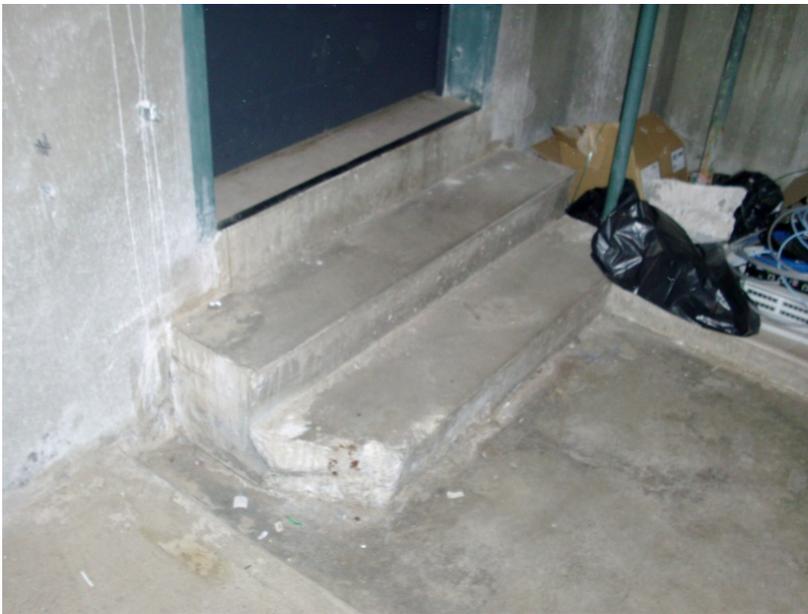
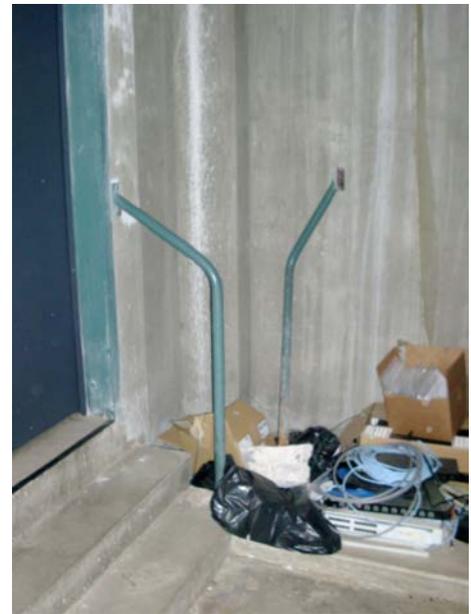
Telecom 13 - Concrete tread broken off at bottom of stair. Stair railing is not functional.

- Repair concrete tread and remount stair railing in Telecom 13.
- Repair cracks and spalled concrete at structural slabs.
- Original Union roof and sun deck coverings are at the end of their life expectancy. They are in need of replacement in the very near future.

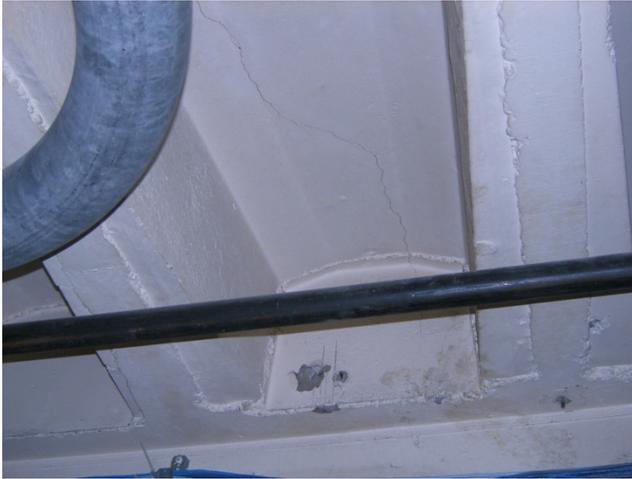
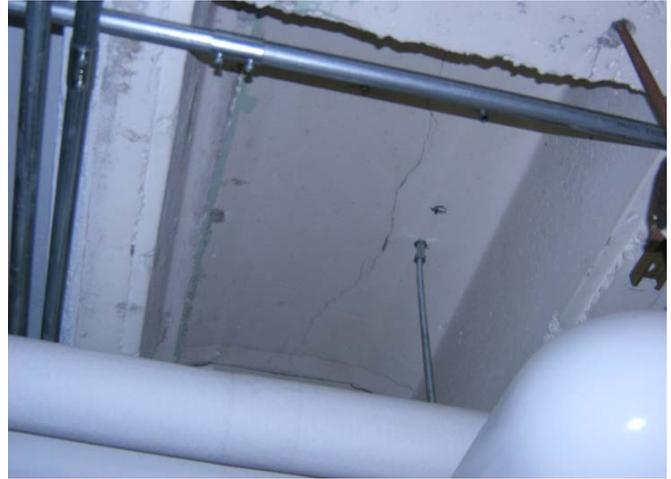
Corridor 81 – Cracks at underside of First Level structural slab (adjacent to Mechanical 11).

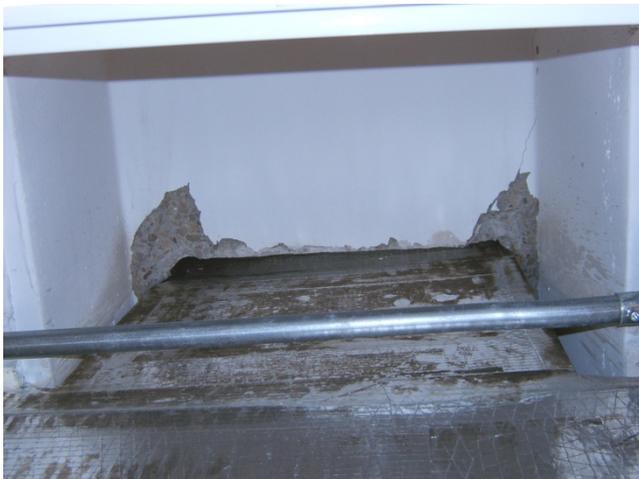
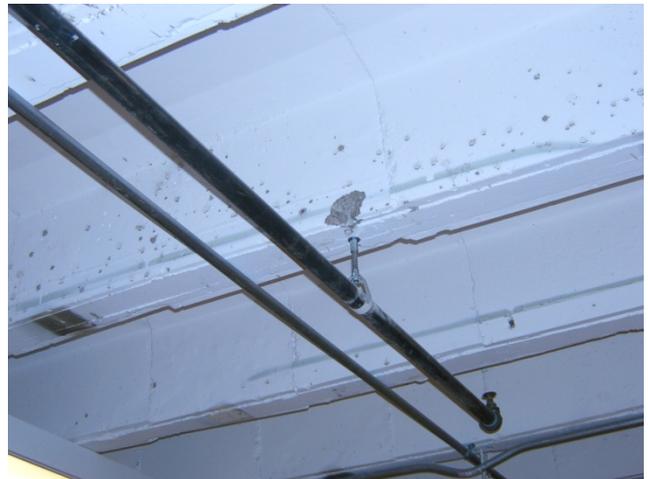
Cash Accounting 9A - Cracks at corners of duct penetration through First Level structural slab (left photo).
Spalled concrete adjacent to pipe hanger connection (right photo).

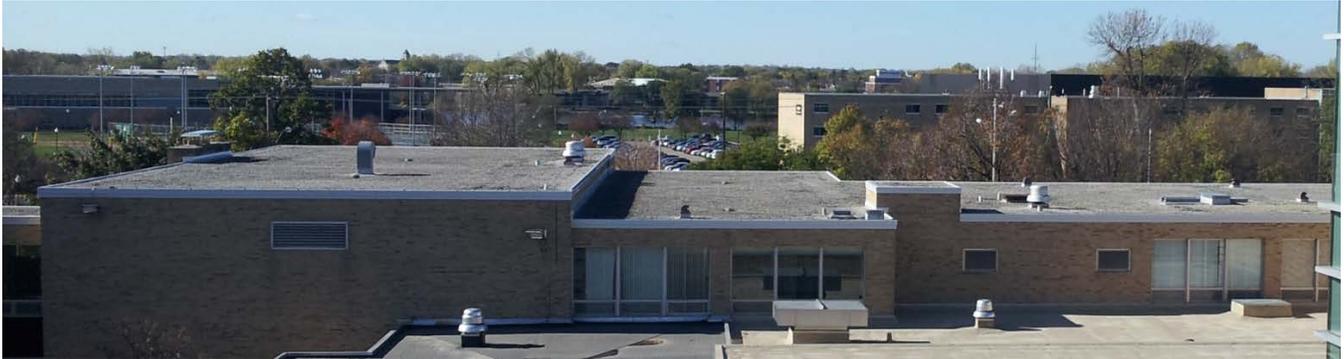
Original Union Roof – Original building roof coverings are in fair to poor condition.

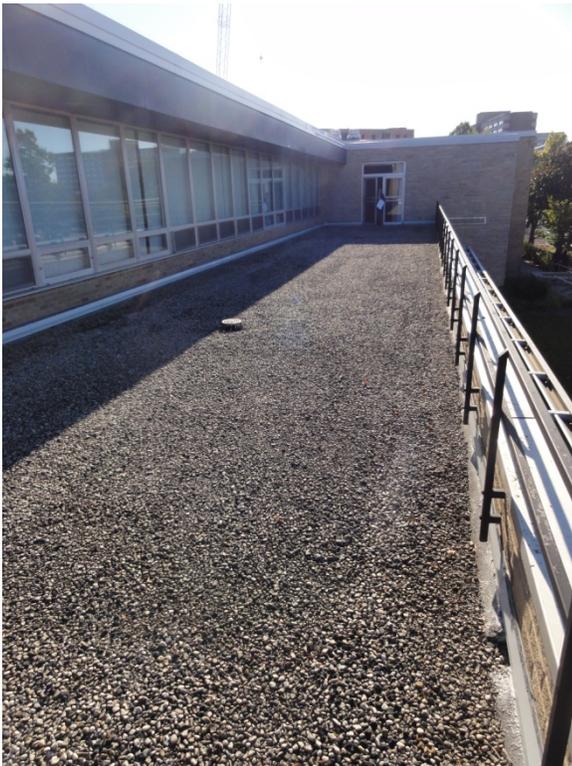
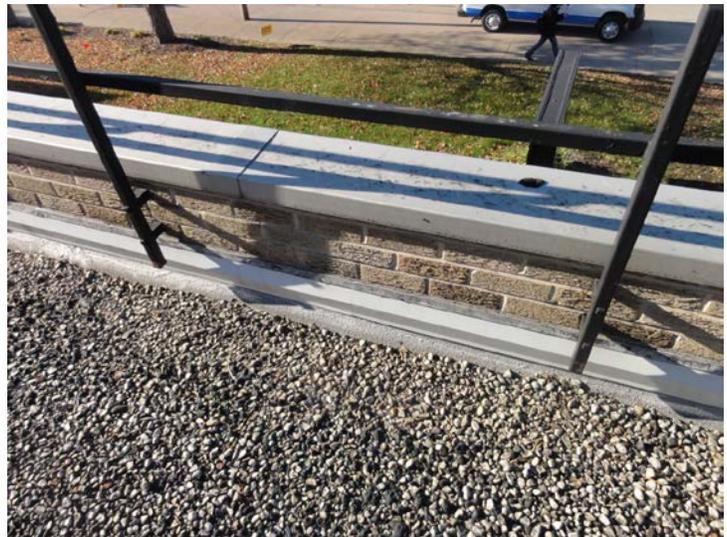
Original Union Sun Deck – Original building roof coverings are in fair to poor condition.
Steel guardrail is showing some signs of corrosion.

- Clean, prime, and top coat exterior exposed steel such as window head lintels and guardrails to prevent further corrosion.
- Create drip edge at Main entrance soffit to prevent further moisture problems.

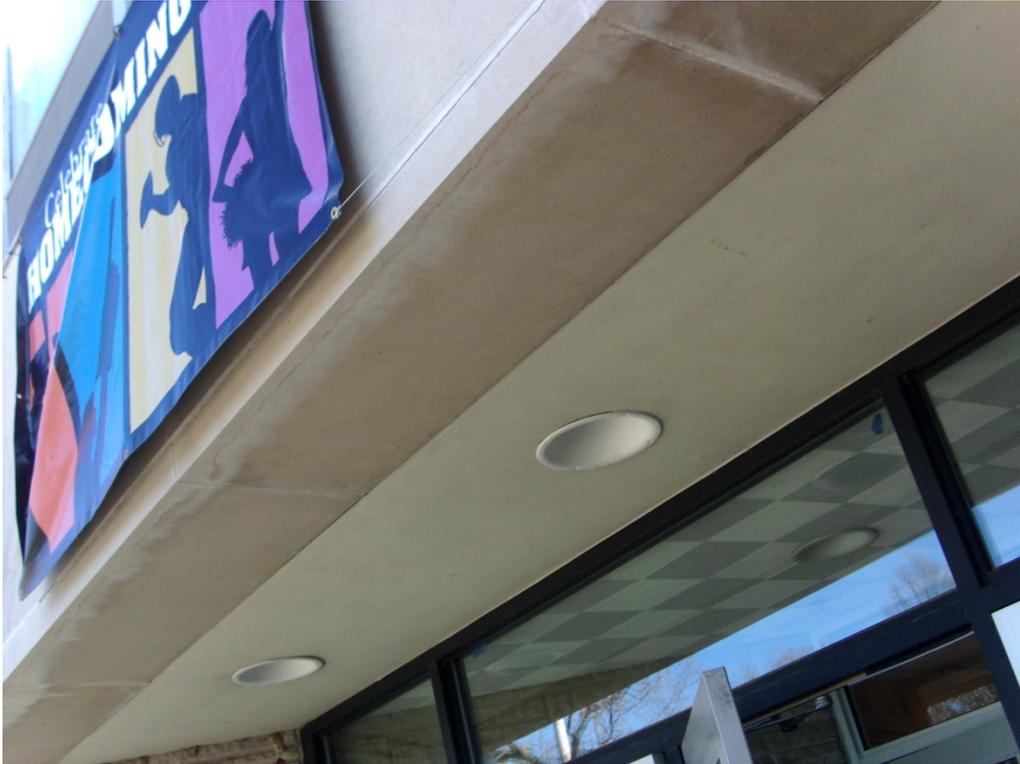
Water stains at Main Entrance soffit, no drip edge provided.

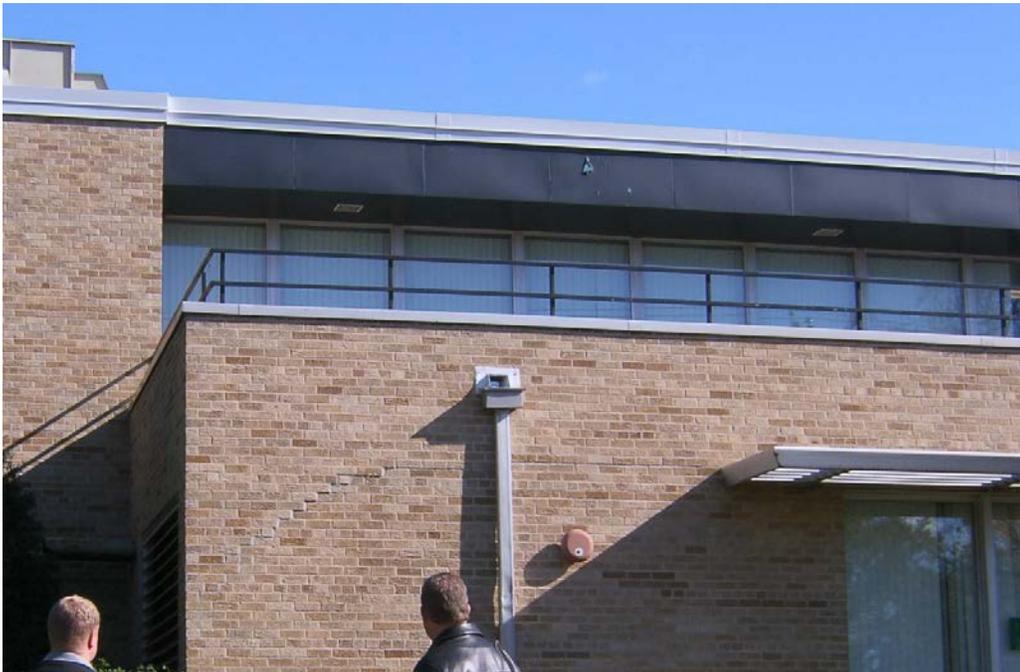
Algoma Street Elevation - Cracks in face brick along at west corner of building.

- Repair cracks in face brick by re-tuck pointing brick joints on a yearly maintenance schedule.
- Further investigation of the brick cracks is warranted. From our experience, it may be necessary to construct expansion joints in the exterior masonry walls based on the types of masonry cracks and movement that were evident.

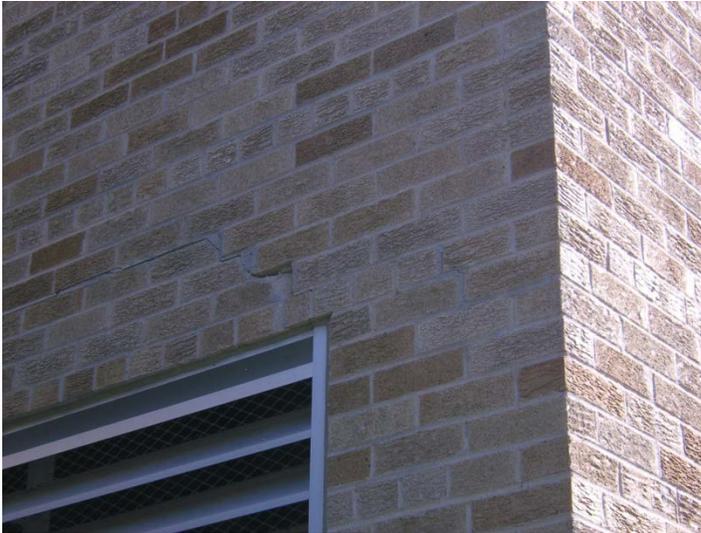
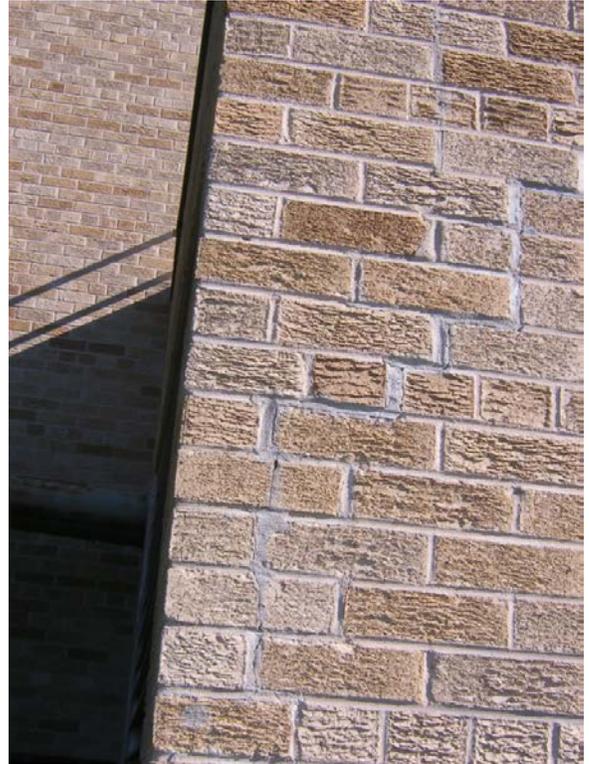
Newer tuck pointing was evident, though cracks have re-appeared in face brick.

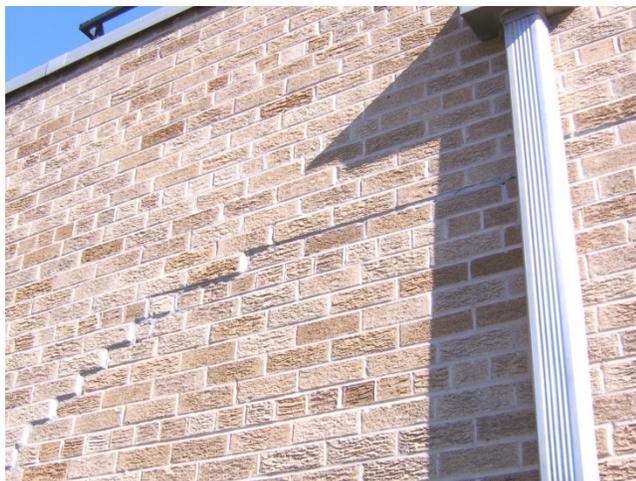
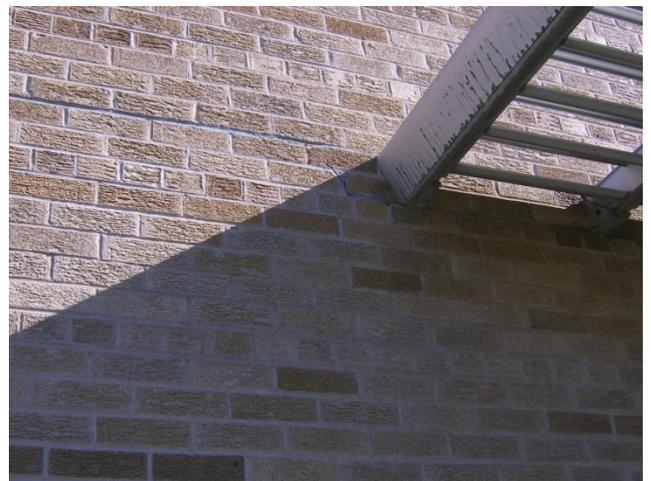
Brick movement was evident, face brick does not align (left photo).
Cracks in face brick continue to the southeast toward the sun screen (right photo).

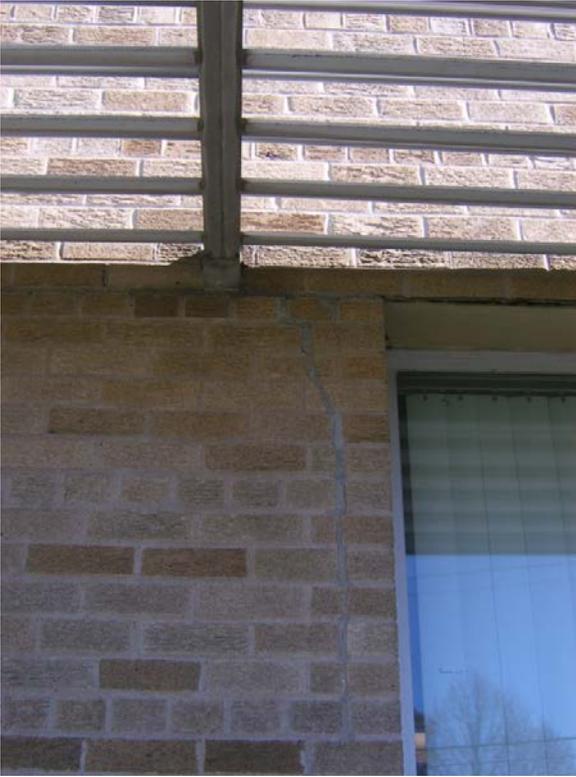
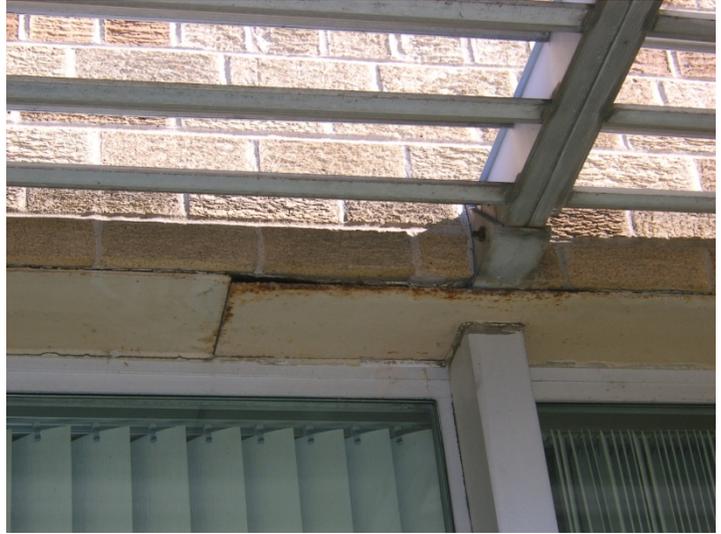
Cracks in face brick follow course beneath sun screen outlookers (left photo). Significant gap and corrosion was evident at end of steel lintel above window head (right photo).

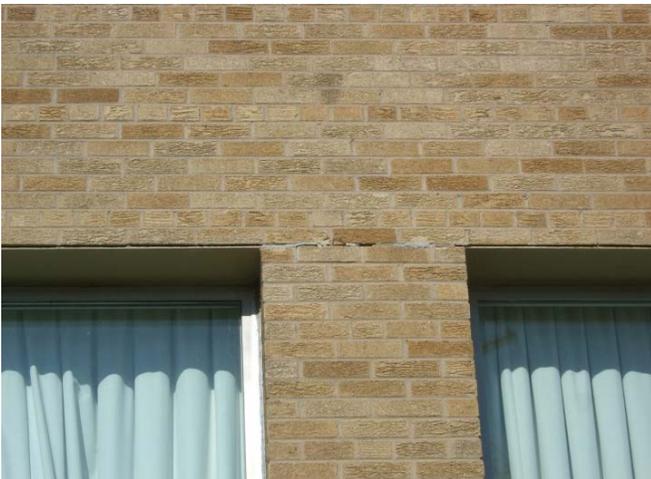
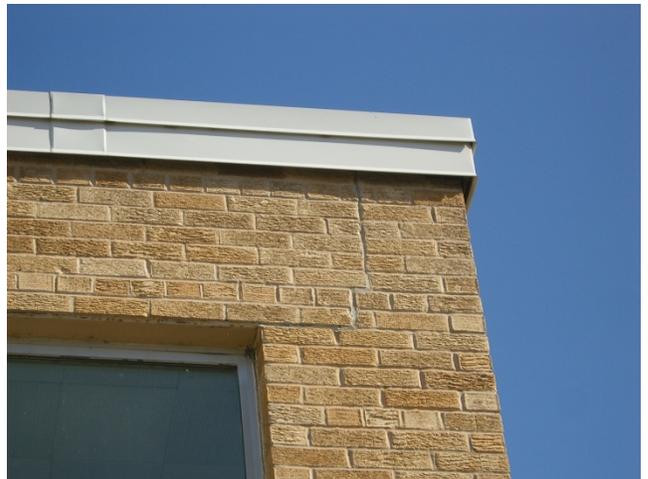
Cracks in face brick continue over to opposite corner of building.

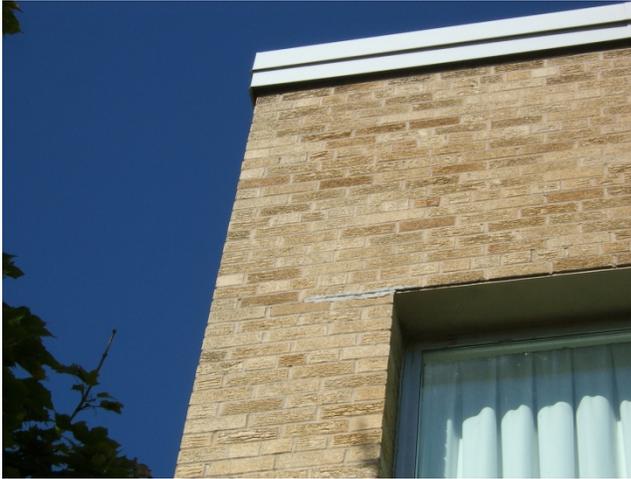
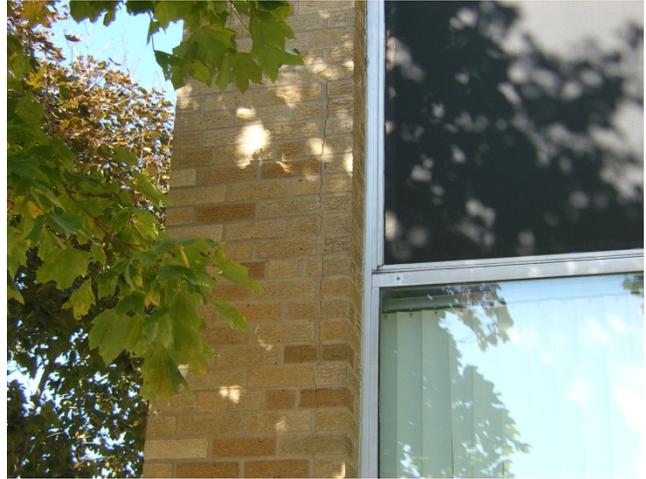
Cracks in face brick continue east around southeast corner of building.

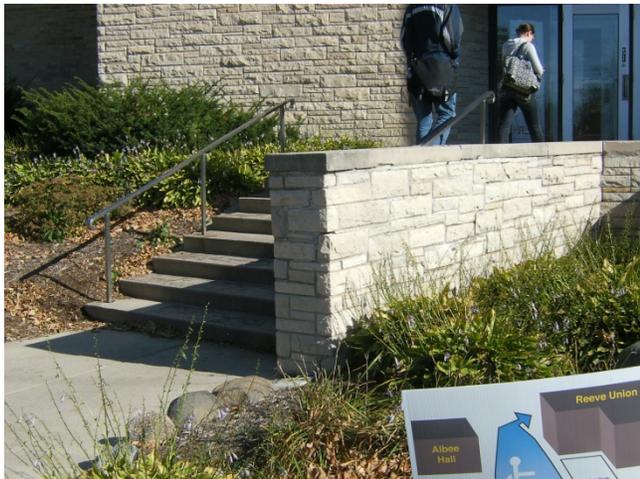
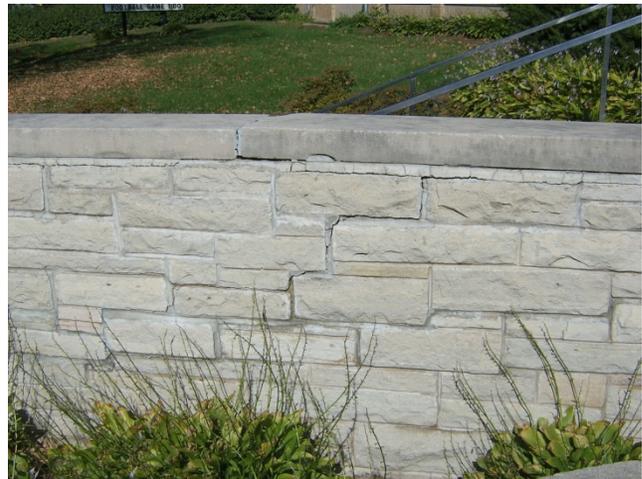
Algebra Street Elevation - Significant cracks were evident in stone retaining wall joints.

- Repair or replace stone retaining wall as necessary.
- Mud-jack settled sidewalks to align tops with adjacent sections.
- Cover exposed light fixture box in stone retaining wall as a minimum. Otherwise remove light fixture box and infill with exterior rated, non-shrink grout.

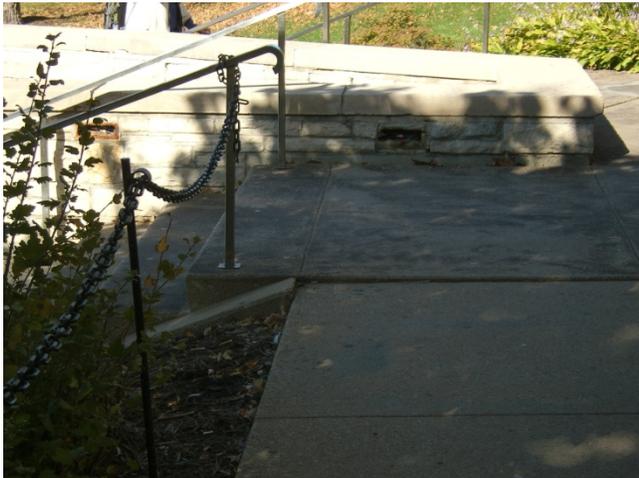
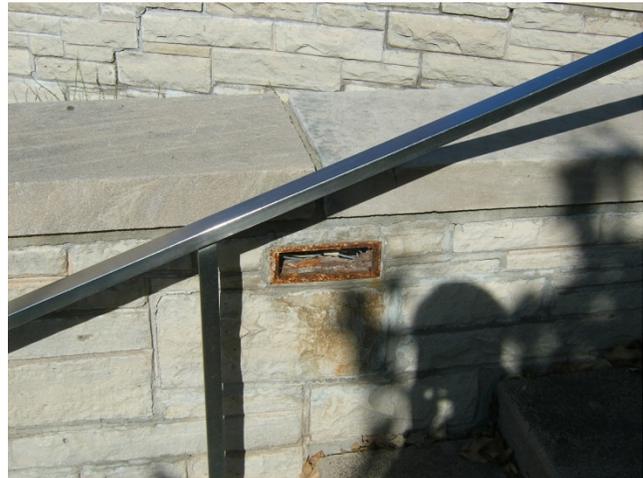
Sidewalk settlement was evident adjacent to exterior stair (left photo). Abandoned steel light fixture box is left exposed to the outdoor elements, thus permitting corrosion and deterioration to the box and stone retaining wall (right photo).
