Reeve Memorial Union

Facility Assessment
DSF No. 08127Z.08

November 2011
Revised January 2012

Reeve Memorial Union - Facility Assessment
University of Wisconsin-Oshkosh | Oshkosh, WI
Comm. No. 5325

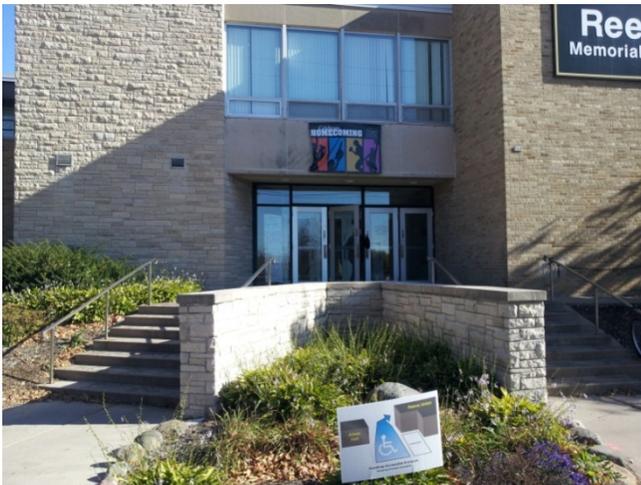
①

The west entry on Algoma Street is a half of a flight of stairs above the sidewalk grade. It is accessed by a stair that approaches the entry from two directions. (Figure 1) Although there is a section of concrete immediately next to the building that ramps up to the entry, it is not a level surface, has no handrails, and is difficult to keep clear of snow in the winter. (Figure 2) Its location is not readily apparent from the main entry. An accessible entry is available by traveling around the building to the north and entering in a section added as part of the 2000 addition. The Algoma Street entrance does not comply with current accessibility codes and regulations.

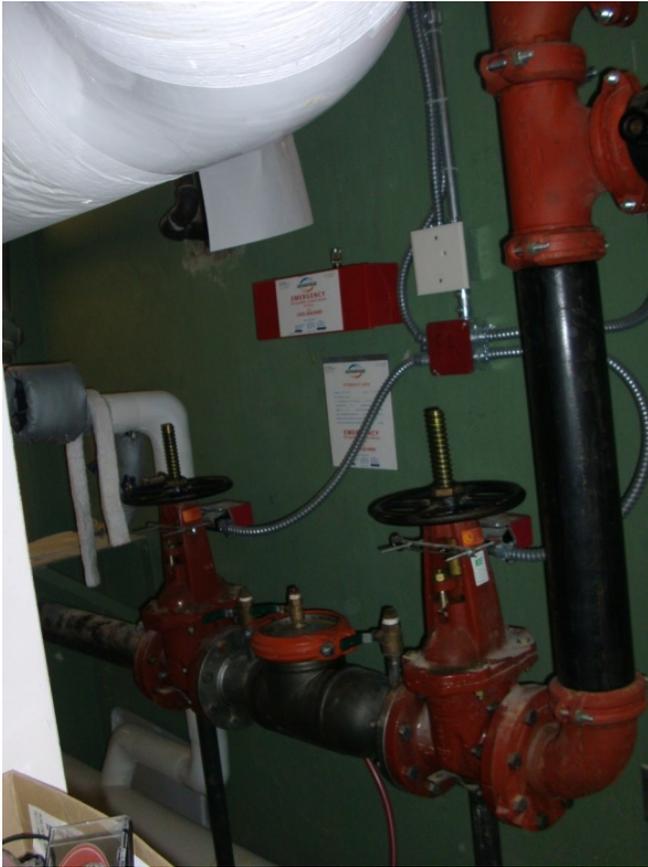
4" Double Check Valve Assembly

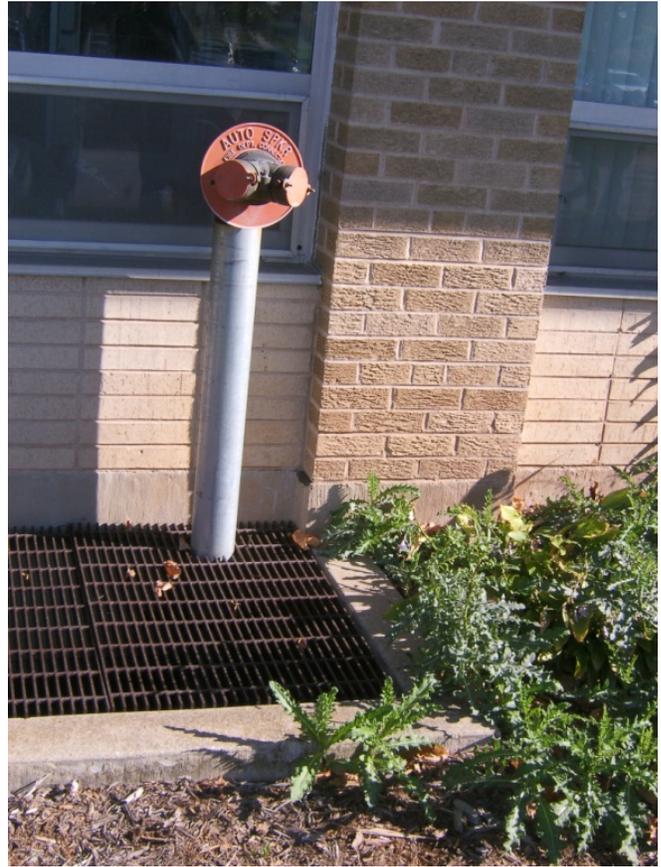
(2) 2 1/2" x 4" Fire Department Connection

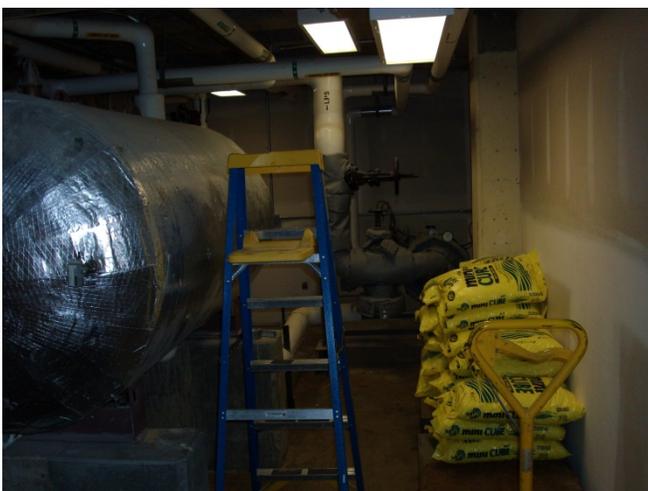
1. Hot water steam generator was installed in 2001. Unit is a Cemline Stonesteel heater, in good condition.
 - a. Storage tank is approx. 460 gallon tank, from the 1963 addition project. Hot water recirculation pump(s) are newer, from 2001.
2. Water piping is copper, majority of it is from 2001 addition. Sanitary and storm piping is cast iron.
3. Exterior grease interceptor, 15,000 gallon capacity, installed in 2001.
4. Water closets are wall-hung, lavatories are wall-hung or counter mounted, urinals are floor mounted. Fixtures are in good condition.

Hot Water Steam Generator and Storage Tank

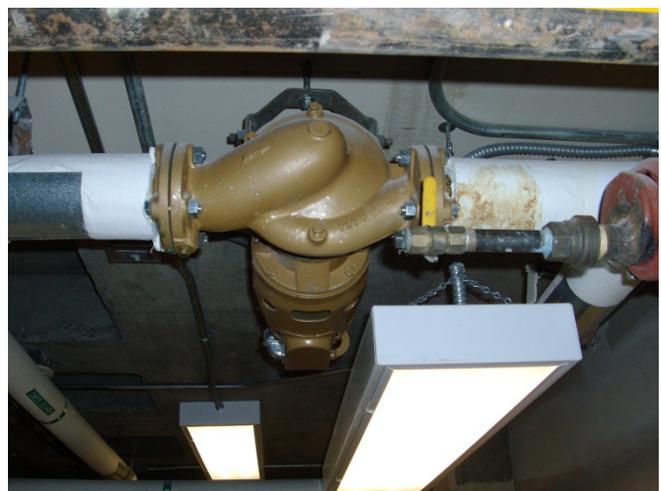
Hot Water Return Recirculation Pump
